TEST REPORT

Report No.: HC90090A/2009

Product Description: M12 Series
Style / Item No.: UT-D230/ UT-D170F/ UT-D168M / No.1
Manufacturer/ Vendor: Unicable Co., Ltd.
Country of Origin: Taiwan
Quantity: Total 1 piece
Testing Period: Sep. 24, 2009 to Sep. 25, 2009

1. Waterproof Test

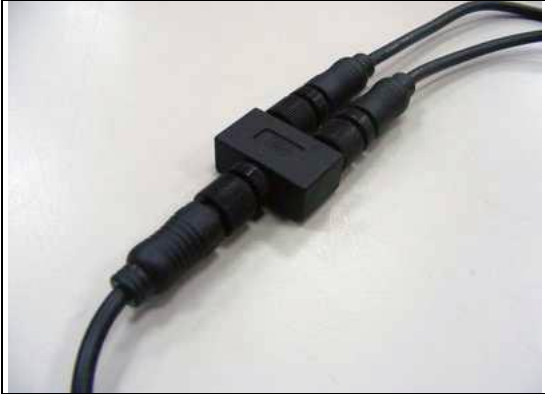
<p>1. Appearance of specimen: UT-D230/ UT-D170F/ UT-D168M</p>	<p>2. Appearance of specimen: UT-D230</p>

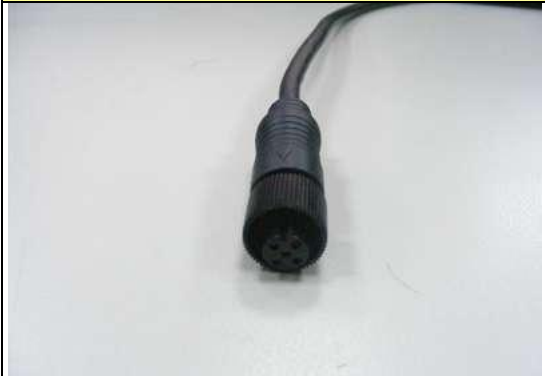
<p>3. Appearance of specimen: UT-D170F</p>	<p>4. Appearance of specimen: UT-D168M</p>

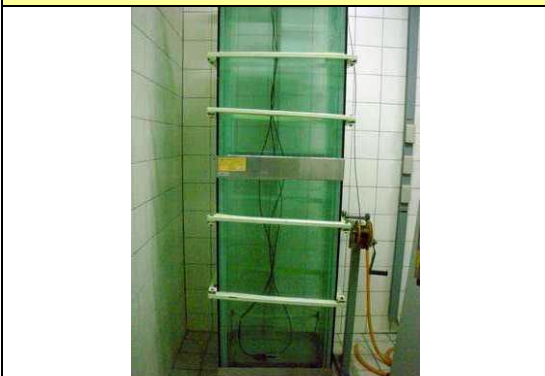
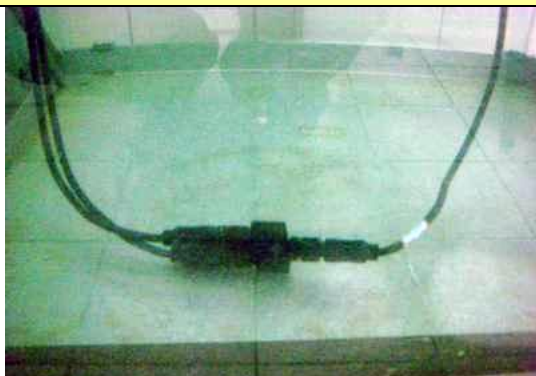
<p>5. Waterproof Test</p>	<p>6. Waterproof Test</p>

Test method: According to IEC 60529 Edition 2.1:2001-02--IPX8

Test means: Completely immerse the specimen in water in its service position as specified by client.

Test condition: The lowest point of enclosures is located 2000 mm below the surface of the water

Test duration: 24 hours

Test Device: As shown in photo 5, 6

Check Item	
Style / Item No.	Provide protection against ingress water?
UT-D230/ UT-D170F/ UT-D168M / No.1	Yes

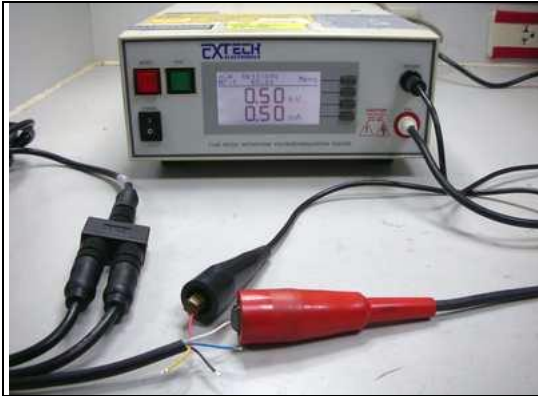
7. Dielectric Withstanding Voltage Test

Applied Voltage: 500 V_{AC}

Frequency: 60 Hz

Duration time: 1 minute

Measuring position: As shown in photo 7, 8

Requirement: No flashover, no spark-over, no excess leakage and no break down between the two contacts of all test samples.

Test Item	
Style / Item No.	Dielectric Withstanding Voltage Test (500 V_{AC}/ 60 Hz, 1 minute)
UT-D230/ UT-D170F/ UT-D168M / No.1	OK
Note: "OK" means no breakdown (leakage current < 0.5 mA)
