## TEST REPORT

Report No.: HCD0143/2009

Product Description: M8 Series  
Style / Item No.: UT-P209F/ UT-P205M / No.1  
Manufacturer/ Vendor: Unicable Co., Ltd.  
Country of Origin: Taiwan  
Quantity: Total 1 piece  
Testing Period: Dec. 22, 2009

1. Waterproof Test

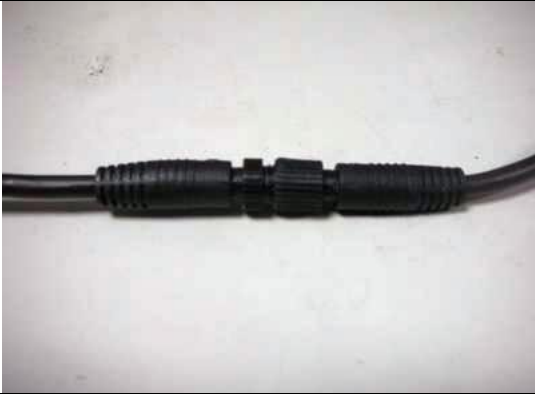
<p>1. Appearance of specimen: UT-P209F/ UT-P205M</p>

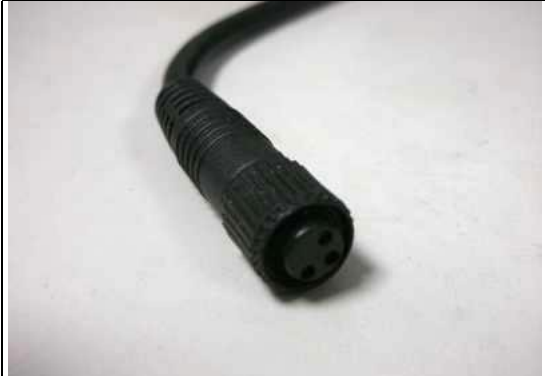
<p>2. Appearance of specimen: UT-P209F</p>	<p>3. Appearance of specimen: UT-P205M</p>

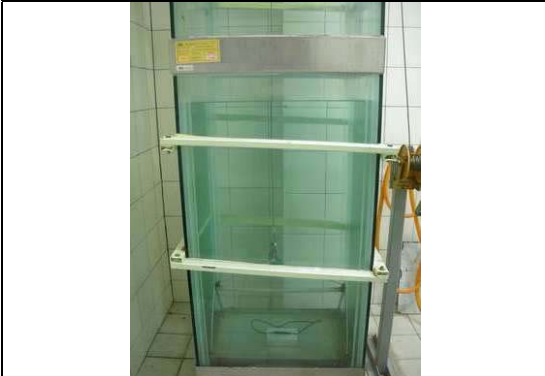
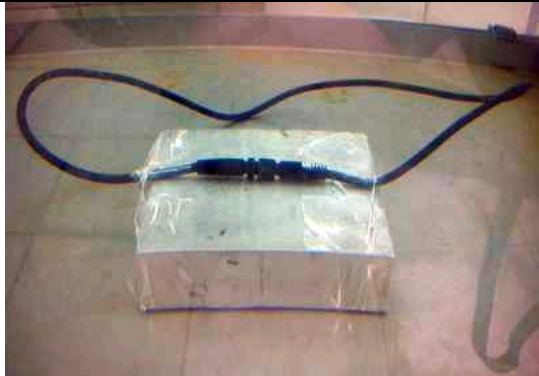
<p>4. Waterproof Test</p>	<p>5. Waterproof Test</p>

Test method: According to IEC 60529 Edition 2.1:2001-02--IPX7

Test means: Completely immerse the specimen in water in its service position as specified by client.

Test condition: The lowest point of enclosures is located 1000 mm below the surface of the water

Test duration: 30 minutes

Test Device: As shown in photo 4, 5

Check Item Style / Item No.	Provide protection against ingress water?
UT-P209F/ UT-P205M / No.1	Yes

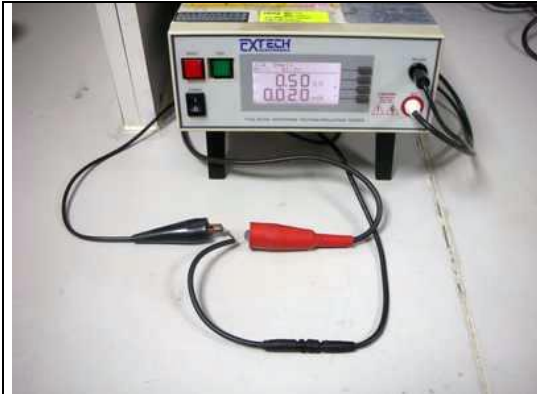
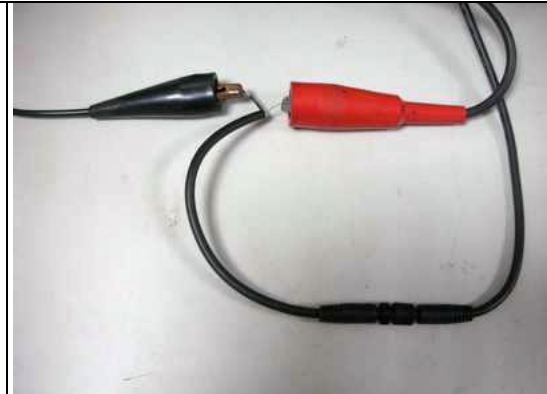
6. Dielectric Withstanding Voltage Test

Applied Voltage: 500 V<sub>AC</sub>

Frequency: 60 Hz

Duration time: 1 minute

Measuring position: As shown in photo 6, 7

Requirement: No flashover, no spark-over, no excess leakage and no break down between the two contacts of all test samples.

Test Item Style / Item No.	Dielectric Withstanding Voltage Test (500 V <sub>AC</sub> / 60 Hz, 1 minute)
UT-P209F/ UT-P205M / No.1	OK

Note: "OK" means no breakdown (leakage current < 0.5 mA)
