## TEST REPORT

Report No.: HCD0042/2009

Product Description: Type A  
Style / Item No.: UT-P207F/ UT-P207M / No.1  
Manufacturer/ Vendor: Unicable Co., Ltd.  
Country of Origin: Taiwan  
Quantity: Total 1 piece  
Testing Period: Dec. 4, 2009

1. Waterproof Test

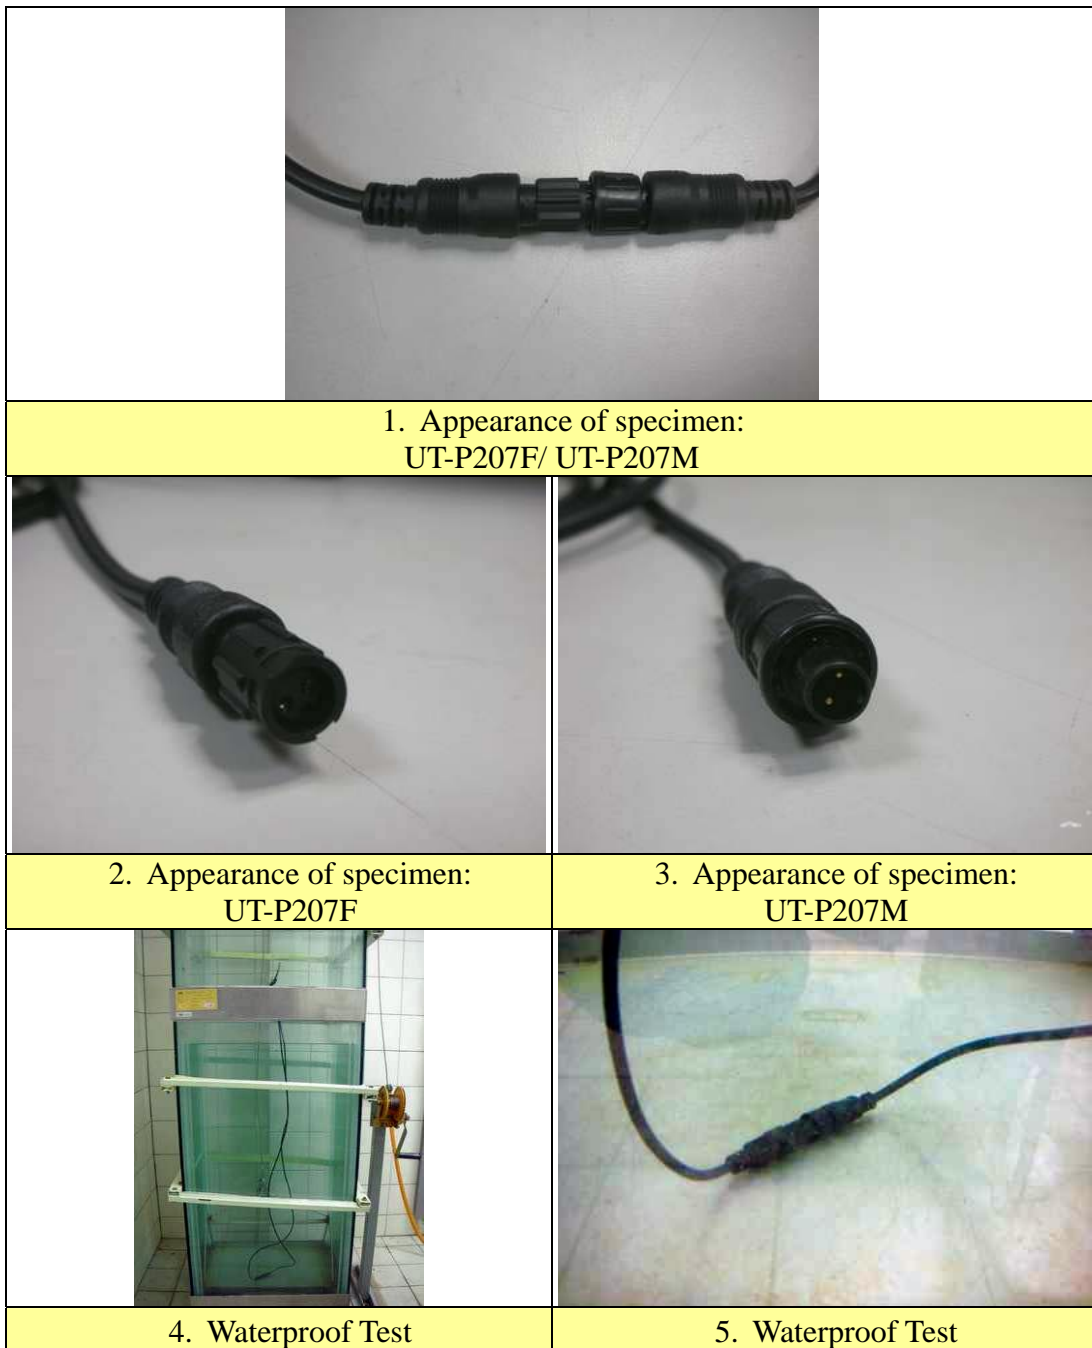
Test Photos:

Test Device: As shown in photo 4, 5

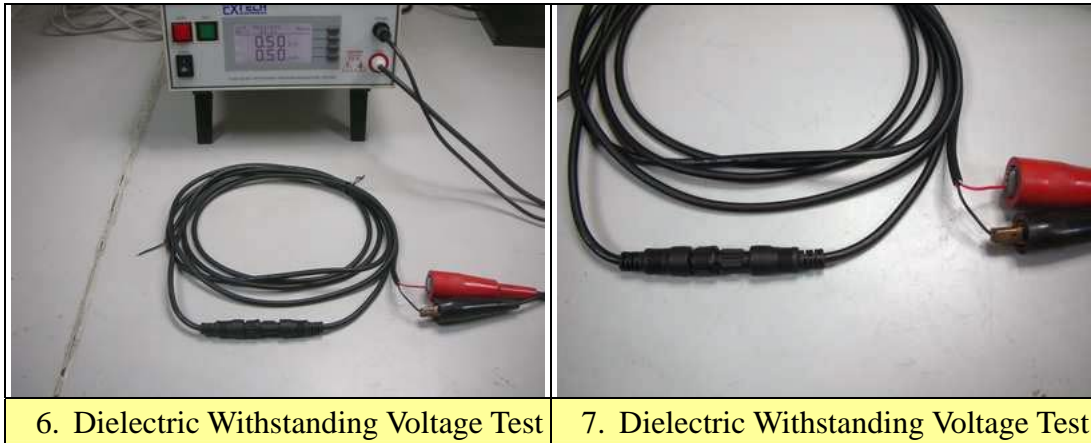
Test Photos--Continued:

Measuring position: As shown in photo 6, 7
